Air Techniques ScanX® Phosphor Storage Plates (PSP) - Reversed Image Prevention (8/08)

Potential Problem with Air Techniques ScanX® Phosphor Storage Plates (PSP) (2/08)

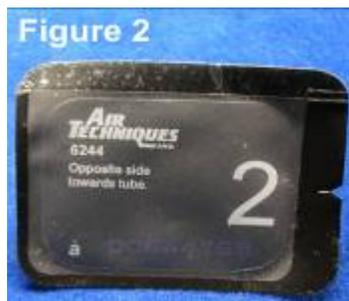
non-sensitive black side with printing, and the radiographic sensitive side which has a blue hue (Figure 1). The intraoral plate is properly placed into a barrier envelope with the printed side visible through the transparent side of the envelope (Figure 2). The PSP is then correctly placed in the mouth when the black, non-transparent side of the barrier envelope is oriented toward the tubehead of the x-ray unit and the transparent side with the underlying printing on the PSP is toward the tongue. If the plate is reversed in the mouth or is incorrectly placed in the protective barrier,

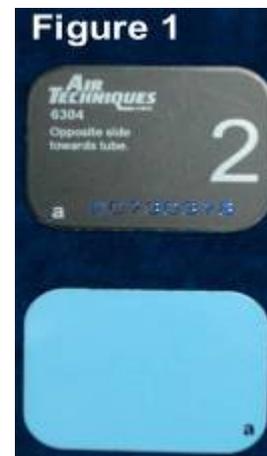
the potential for a reversed/mirror image exists. There is no radiographic marker (e.g., lead foil in conventional x-ray film) on the non-sensitive side of the PSP which would alert the viewer that the image has been taken improperly. An orientation letter "a" is

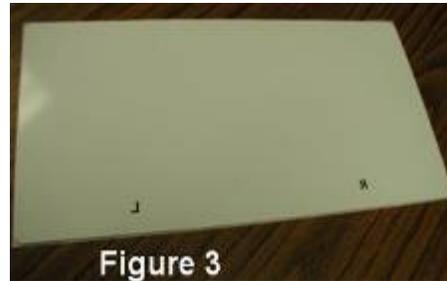
Recent testing of Air Techniques PSP panoramic digital images using a Gendex, Orthoralix 9000 unit, revealed the same potential for reversed images. Since the "R" and "L" radiographic markers are imbedded in the plate on the sensitive side, the same problem occurs as described with the "a" on the intraoral PSPs (Figure 3).

Problem Resolution: The AF Dental Service and DECS are working closely with Air Techniques to reduce the potential for reversed images. A solution devised by Air Techniques would appear to require reengineering the intraoral and panoramic PSPs with permanent radiographic markers on the non-sensitive side of the plates or applying company-approved external markers which are compatible with scanning devices.

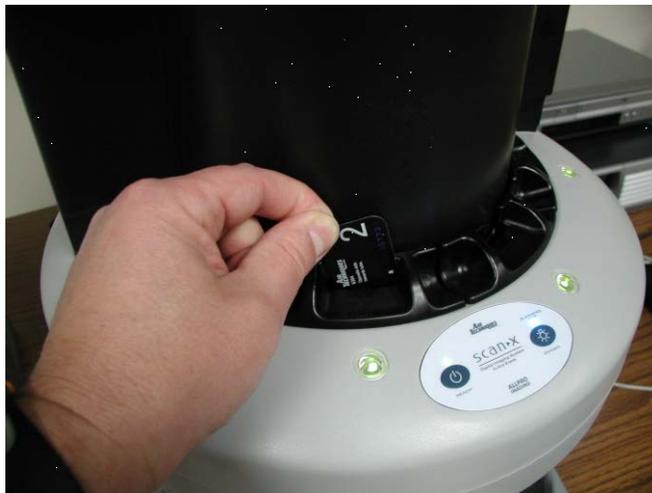
Air Techniques scanner always scans the image from the sensitive side
