Report of a Dental Lab Accident (2/09)

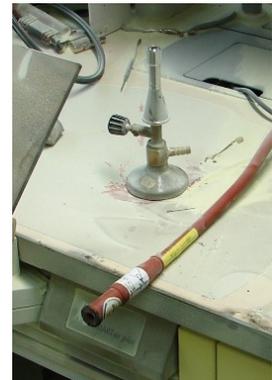
One USAF dental laboratory recently reported an accident that may be of interest to other dental labs. Following a recent renovation, a lab technician was waxing a crown with the Bunsen burner turned on. The gas hose feeding the burner suddenly disconnected from the burner and gas exiting the hose ignited. It was determined that the pressure in the facility's natural gas piping (7.25 psi) was much higher than normal (0.5 psi is typical) and the increased pressure resulted in the hose breaking free from the burner connection. While dental personnel are not required to monitor facility gas line pressure, it is good to be aware of this isolated incident.
