Dental Digital Radiology Solution (DDRS) Updates

Air Techniques ScanX® Phosphor Storage Plates (PSP) - Reversed Image Prevention (8/08)

Potential Problem with Air Techniques ScanX® Phosphor Storage Plates (PSP) (2/08)

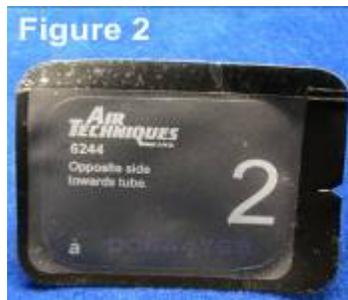
Product Design/Potential Placement Errors: Air Techniques PSPs have two sides: a non-sensitive black side with printing, and the radiographic sensitive side which has a blue hue (Figure 1). The intraoral plate is properly placed into a barrier envelope with the printed side visible through the transparent side of the envelope (Figure 2). The PSP

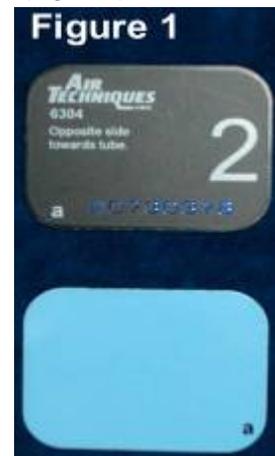
is then correctly placed in the mouth when the black, non-transparent side of the barrier envelope is oriented toward the tubehead of the x-ray unit and the transparent side with the underlying printing on the PSP is toward the tongue. If the plate is reversed in the mouth or is incorrectly placed in the protective barrier, the potential for a reversed/mirror image exists. There is no radiographic marker (e.g., lead foil in conventional x-ray film) on the non-sensitive side of the PSP which would alert the viewer that the image has been taken improperly. An orientation letter "a" is printed on the intraoral PSP and according to the manufacturer "may be used for reference

as you would use the dot on an intraoral x-ray film." However, since the [Air Techniques scanner always scans the image from the sensitive side](#), the "a" will always appear in the appropriate orientation, even if the image was exposed from the wrong side ([click here](#) for additional information).

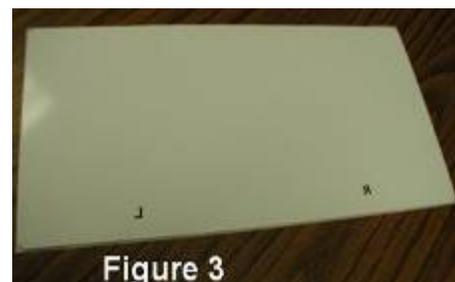
Recent testing of Air Techniques PSP panoramic digital images using a Gendex, Orthoralix 9000 unit, revealed the same potential for reversed images. Since the "R" and "L" radiographic markers are imbedded in the plate on the sensitive side, the same problem occurs as described with the "a" on the intraoral PSPs (Figure 3).

Problem Resolution: The AF Dental Service and DECS are working closely with Air Techniques to reduce the potential for reversed images. A solution devised by Air Techniques would appear to require reengineering the

intraoral and panoramic PSPs with permanent radiographic markers on the non-sensitive side of the plates or applying company-approved external markers which are compatible with scanning devices.

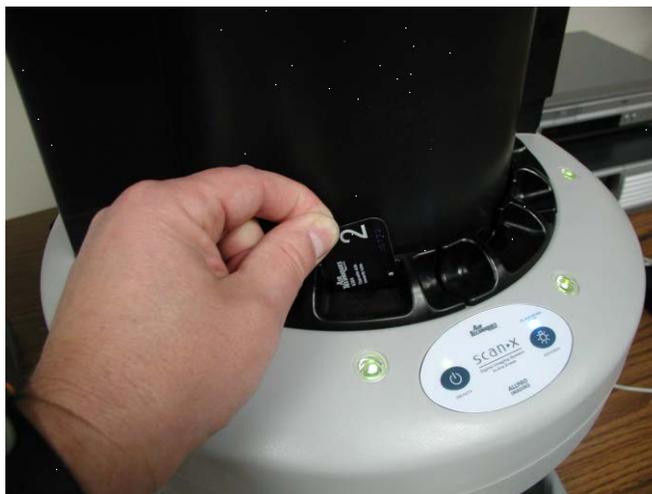
Air Techniques scanner always scans the image from the sensitive side
