Patient Mishap Involving a Metal Three-Way Syringe Tip (11/02)

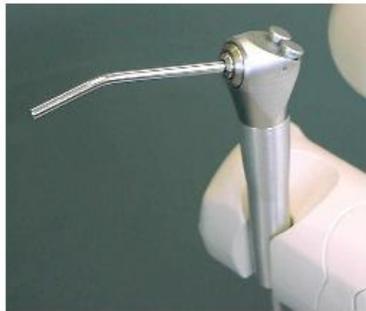
Typical Three-Way Syringe with Inserted Tip
