Reconditioning of Ormco Wire Cutters (11/00)

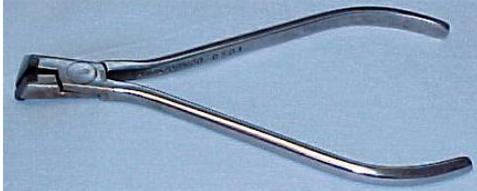
surgically removed. The DEC (item number 803-0501 in Ormco's catalog) is a pliers-shaped instrument used to cut round and rectangular orthodontic wires distal to buccal tubes. The instrument has a "hold" feature that is intended to hold the cut piece of wire to prevent it from dropping into the oral cavity. In this particular case, the hold feature did not function properly and the wire injured the patient. In attempting to determine why

Instructions provided with the DEC note that "cutting instruments that are used frequently (determined by provider) should be reconditioned every six to nine months." Ormco recommends reconditioning for all their wire-cutting instruments. The reconditioning (which may involve parts replacement, resurfacing, sharpening, polishing, buffing, and lubrication) should ensure that the instrument cuts efficiently and retains the separated piece of wire. It is important to note that the cost of reconditioning an instrument may vary, depending on its type and existing condition. Ormco provided to DIS the cost of various reconditioning services, however, facilities should contact Ormco for a current price quote before sending instruments in for service.

While it is encouraging that the manufacturer has recently included an information booklet with the wire cutters that describes its proper care and use, it should be noted that there is no reference to the size(s) of wire that can be cut. Also, the booklet uses a small font size when discussing reconditioning and sharpening. As a result, clinicians and staff could easily overlook this guidance. DIS has recommended to Ormco that it make specific reference in its product booklet to the size(s) of wire that are appropriate for cutting with the instrument. In addition, the company should list its recommendations for reconditioning and sharpening in bold distinctive letters for ease of reading. DIS also recommends that the NCOIC of Dental Logistics at dental clinics brief personal on the proper use and care of the wire cutters, and that clinicians always make a test cut before using them to ensure that the "hold" feature works properly.
