Air Techniques ScanX® Phosphor Storage Plates (PSP) - Reversed Image Prevention (8/08)

Potential Problem with Air Techniques ScanX® Phosphor Storage Plates (PSP) (2/08)

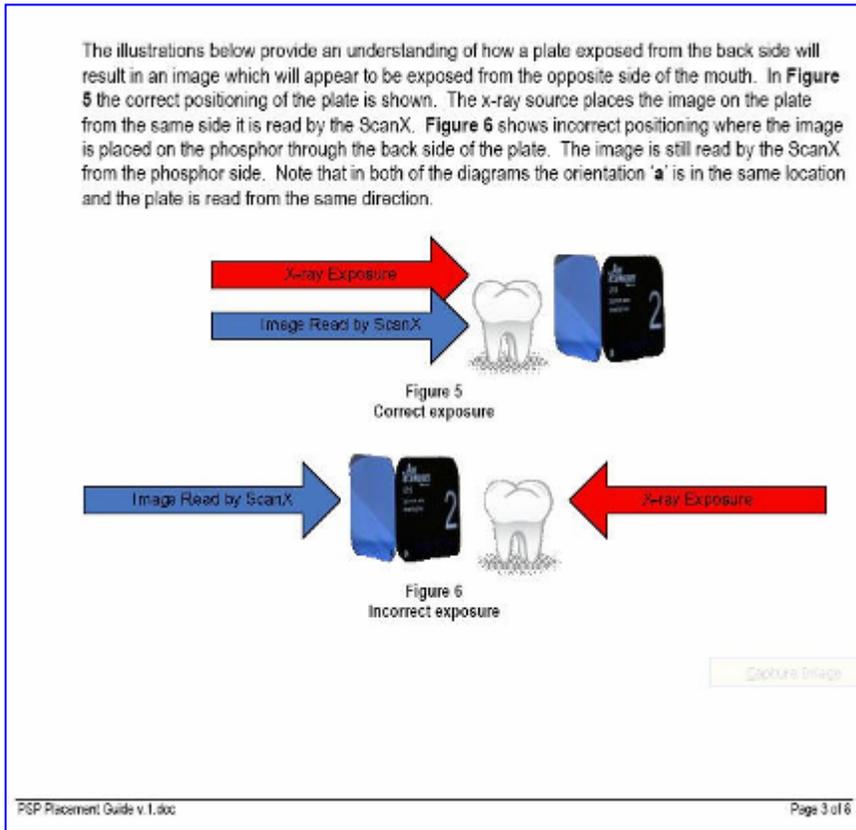
From the PSP Placement Guide

the potential for a reversed/mirror image exists. There is no radiographic marker (e.g., lead foil in conventional x-ray film) on the non-sensitive side of the PSP which would alert the viewer that the image has been taken improperly. An orientation letter "a" is

Air Techniques scanner always scans the image from the sensitive side

Staff Review Recommendations: Air Force dental facilities are highly encouraged to review proper PSP placement within the barrier envelopes and proper intraoral positioning with the entire dental team. Techniques for proper placement of the panoramic plates within the cassettes should be reviewed. Dental officers are encouraged to maintain a high degree of vigilance to ensure that digital radiographic images coincide with dental anatomy, previous restorations and any other anatomical landmarks which could indicate a reversed image.
